THE
GREAT EARTHQUAKE
OF JAPAN

1891.

BY
JOHN MILNE.
AND
W.K. BURTON.
PLATES BY K. OGAWA.

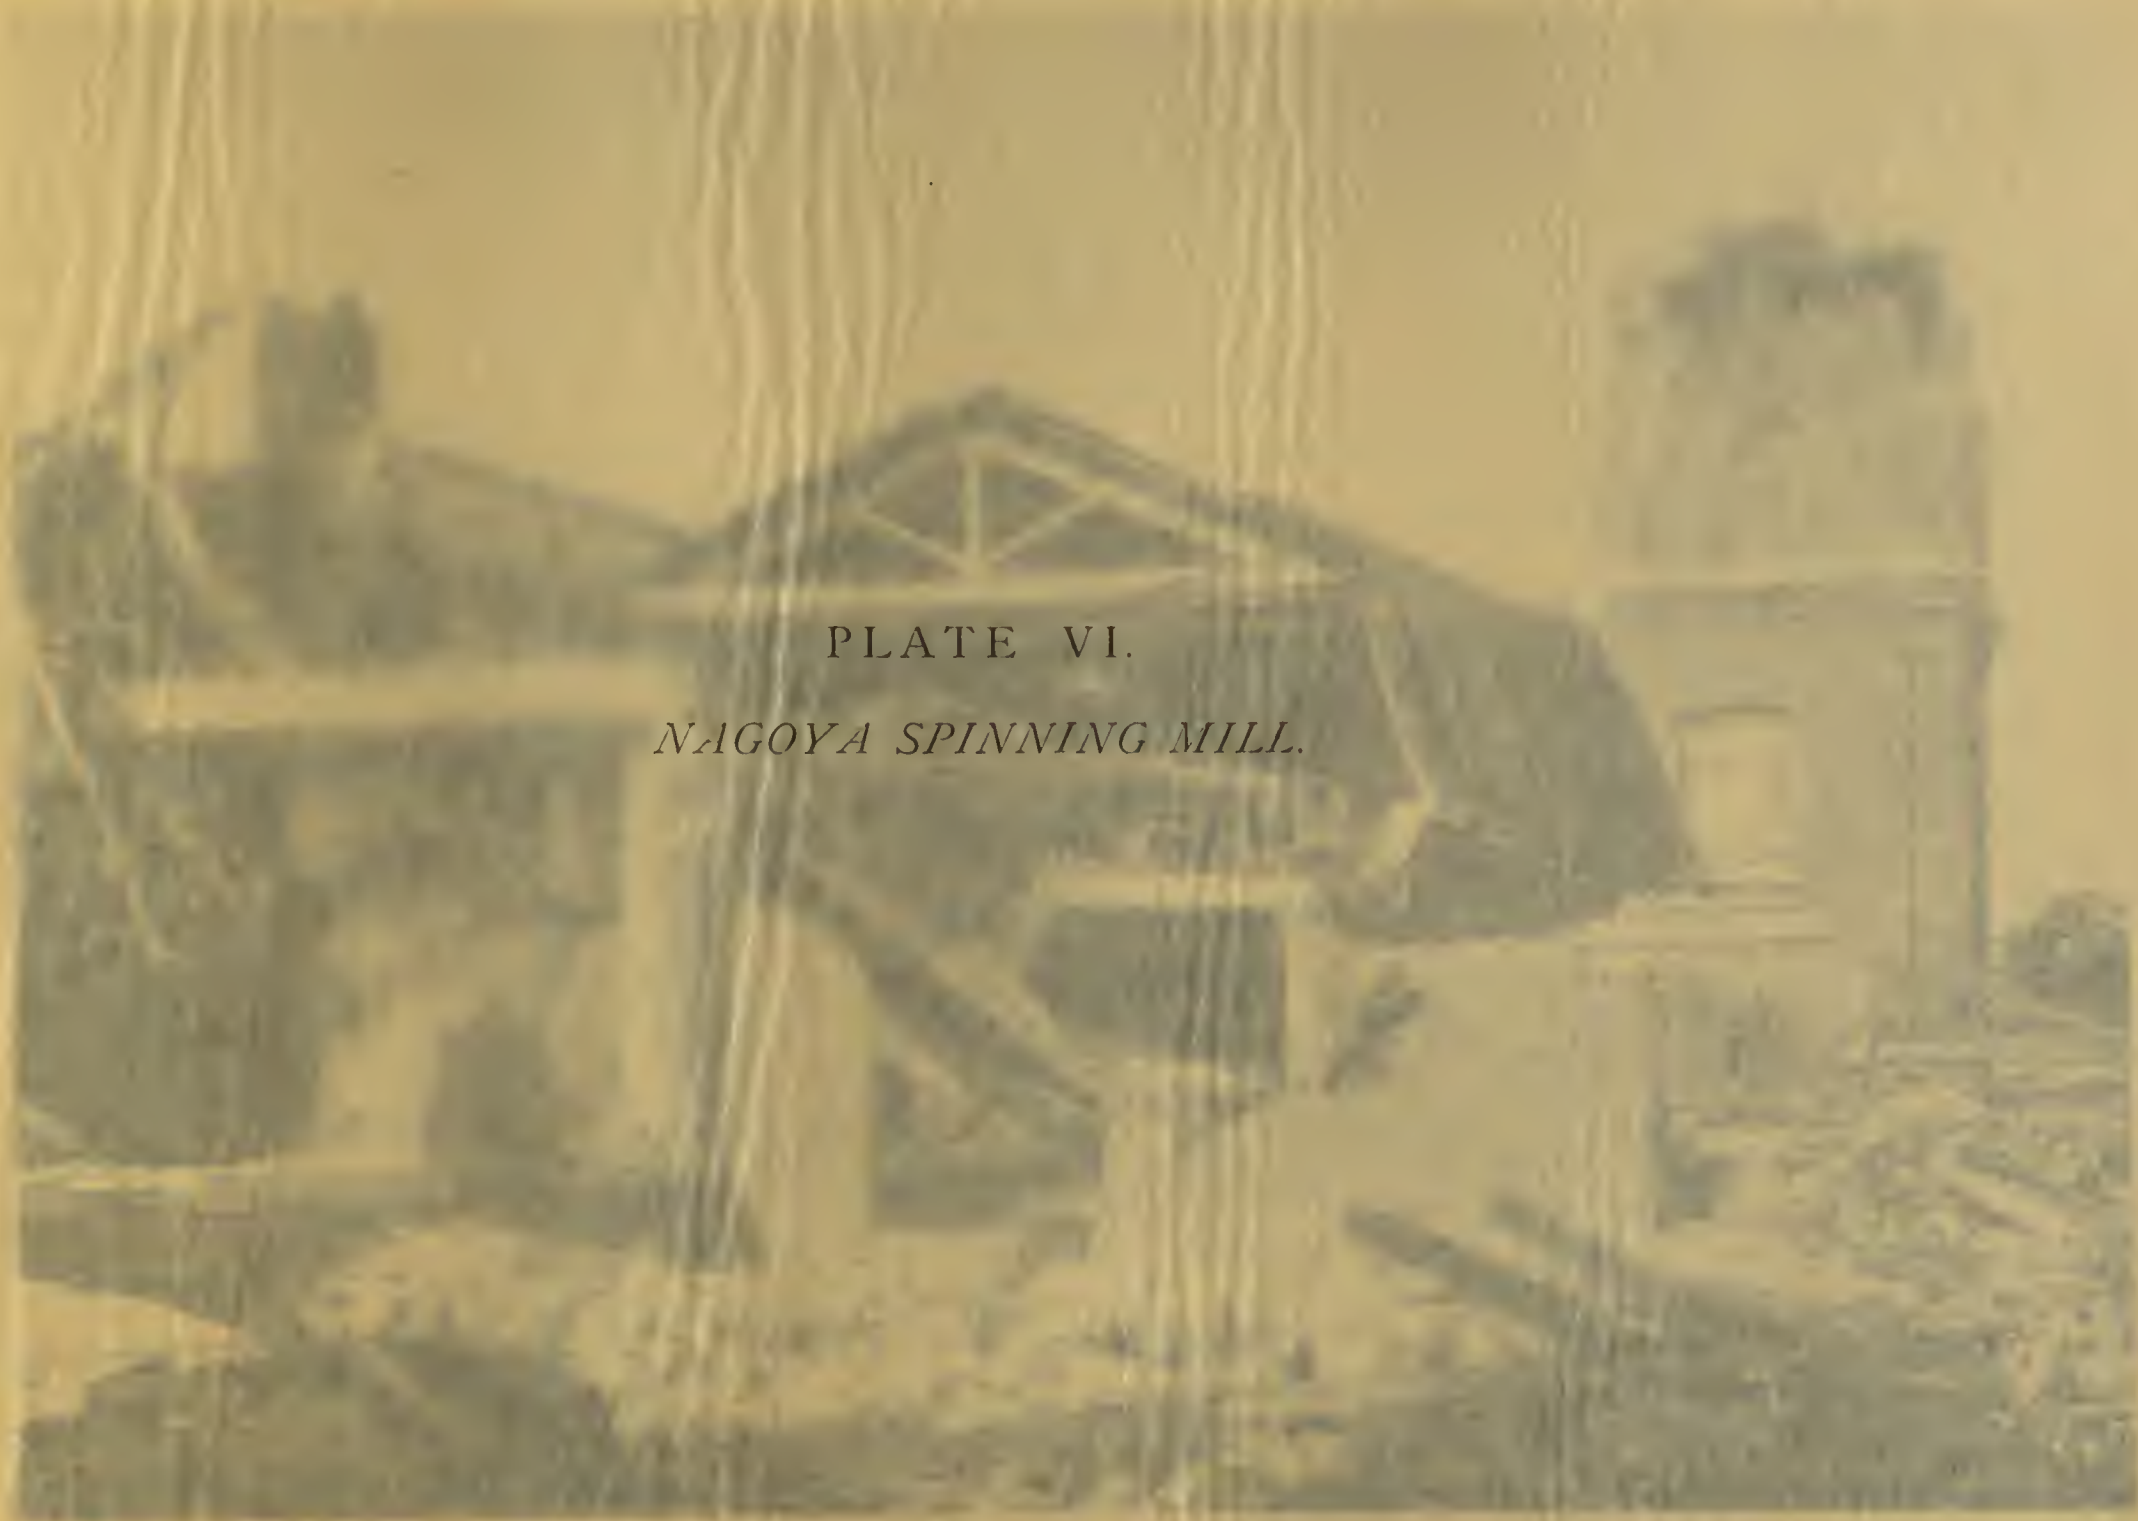
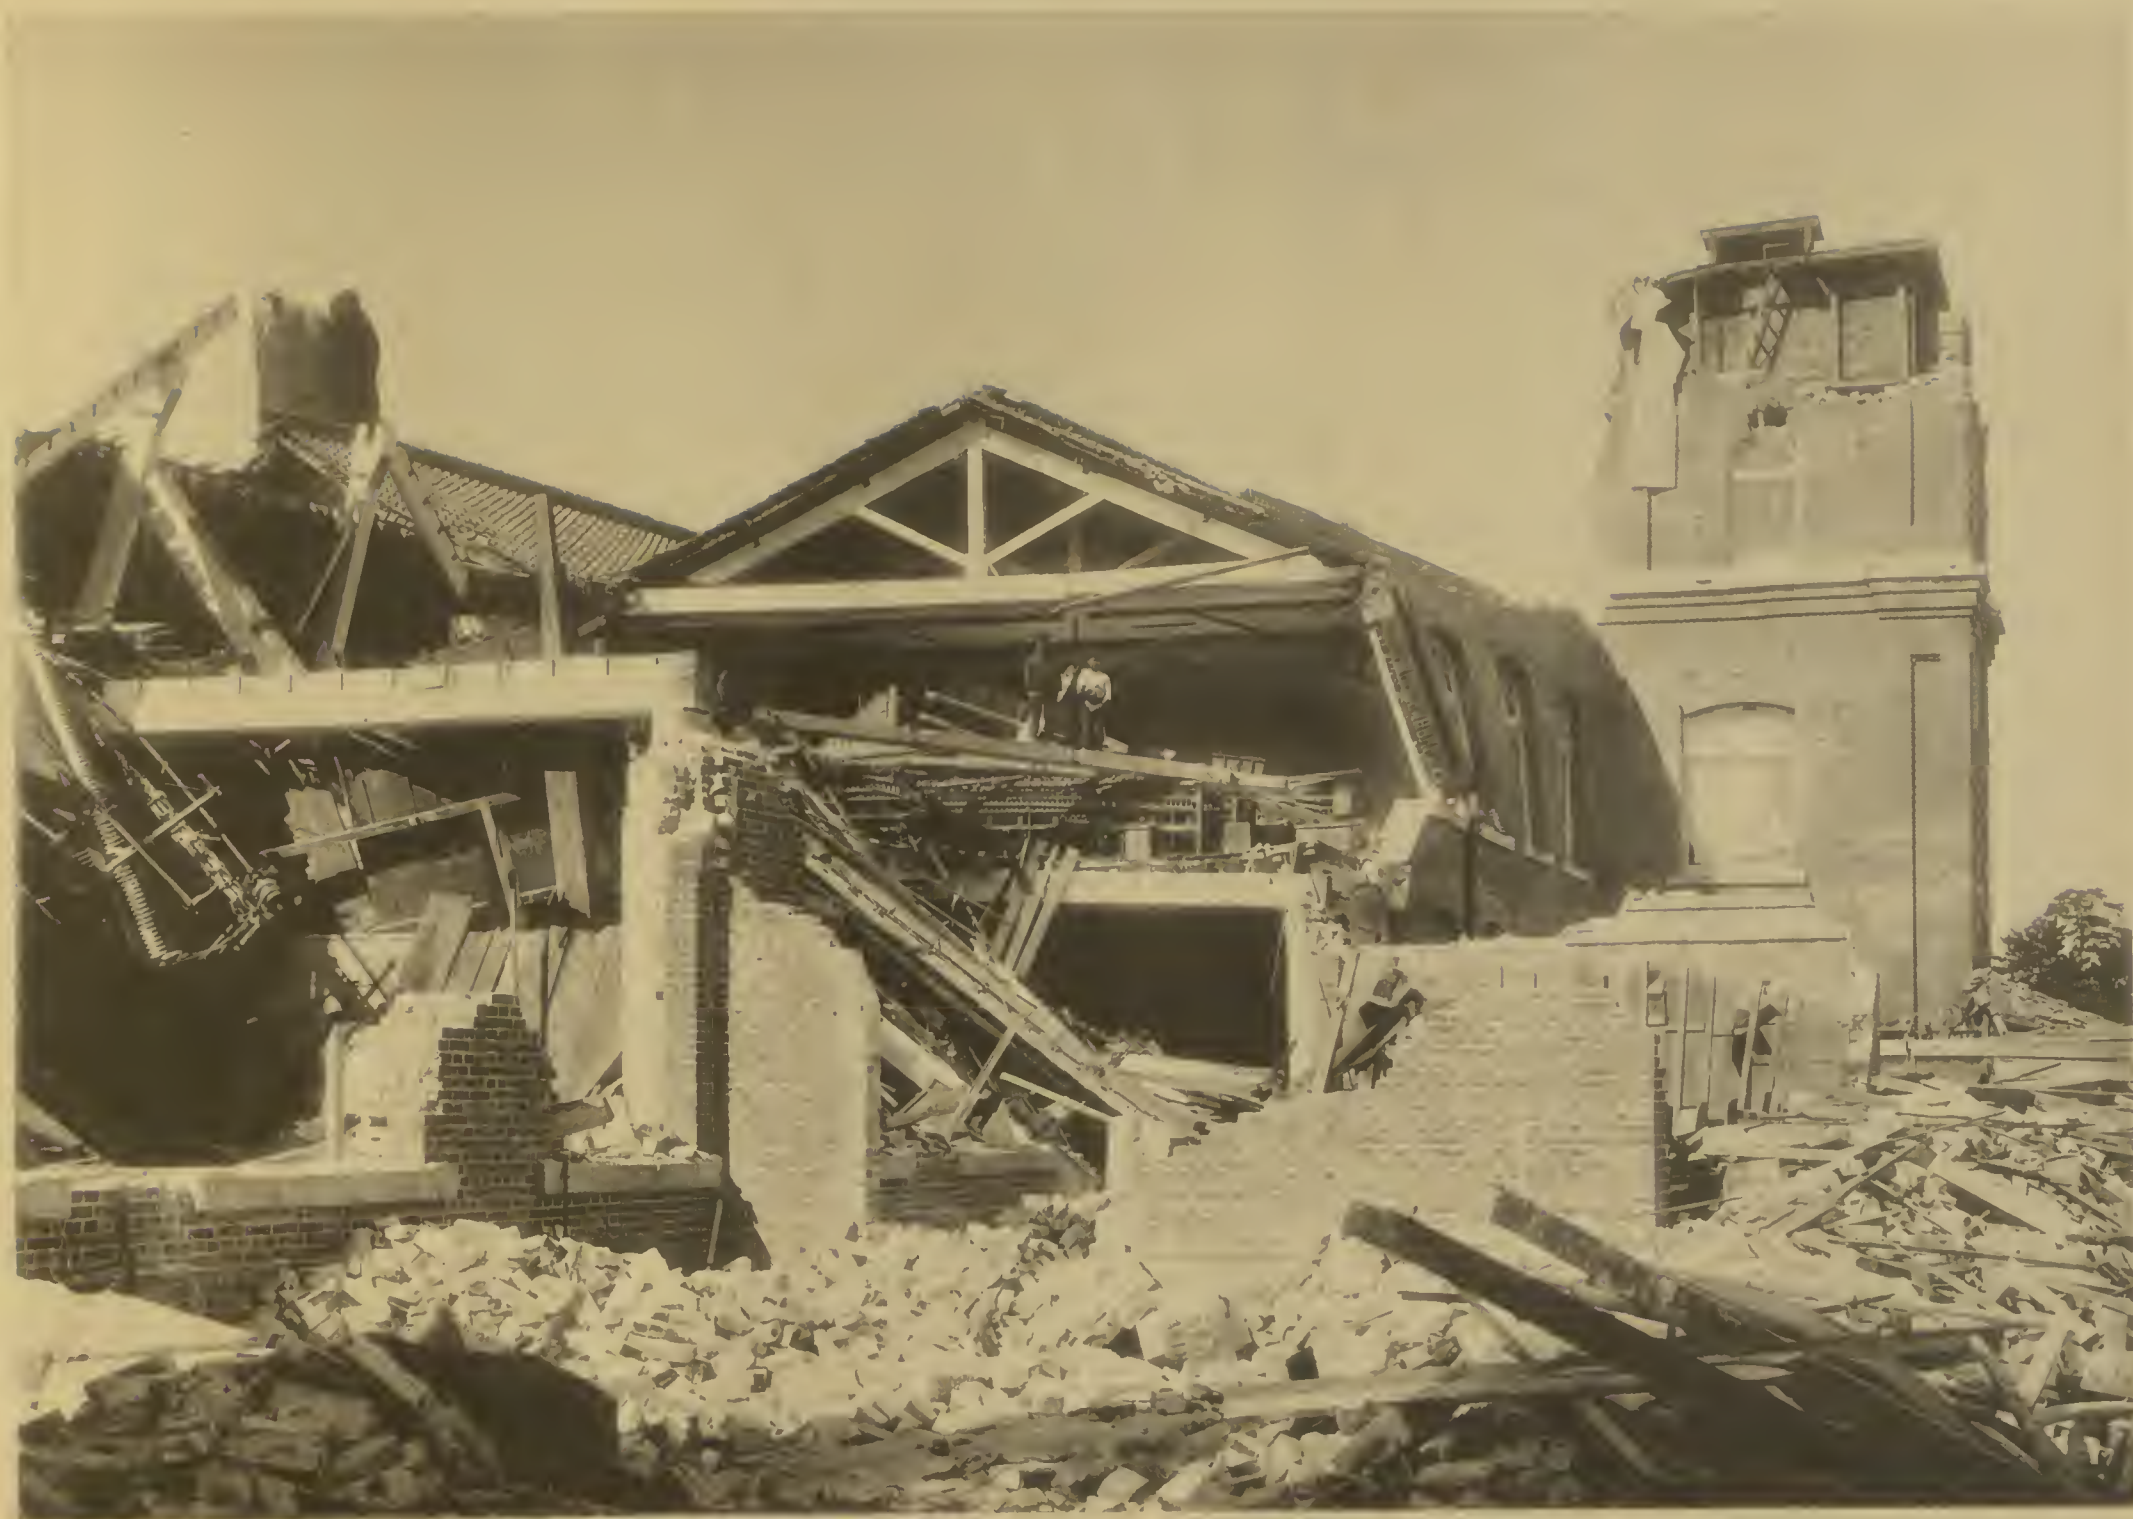
PLATE VI.
NAGOYA SPINNING MILL.

The building is in a terribly wrecked condition; there are not more than about half the walls standing, and these are cracked, twisted, and half overset.

In looking at the picture, it will be observed that, although the walls are fairly thick, from the way the bricks have separated we may imagine that the cohesive power of the mortar was not very great.

The cracks above the windows in the tower show that openings in walls form lines of weakness, and, as such, they require special consideration from the builder.

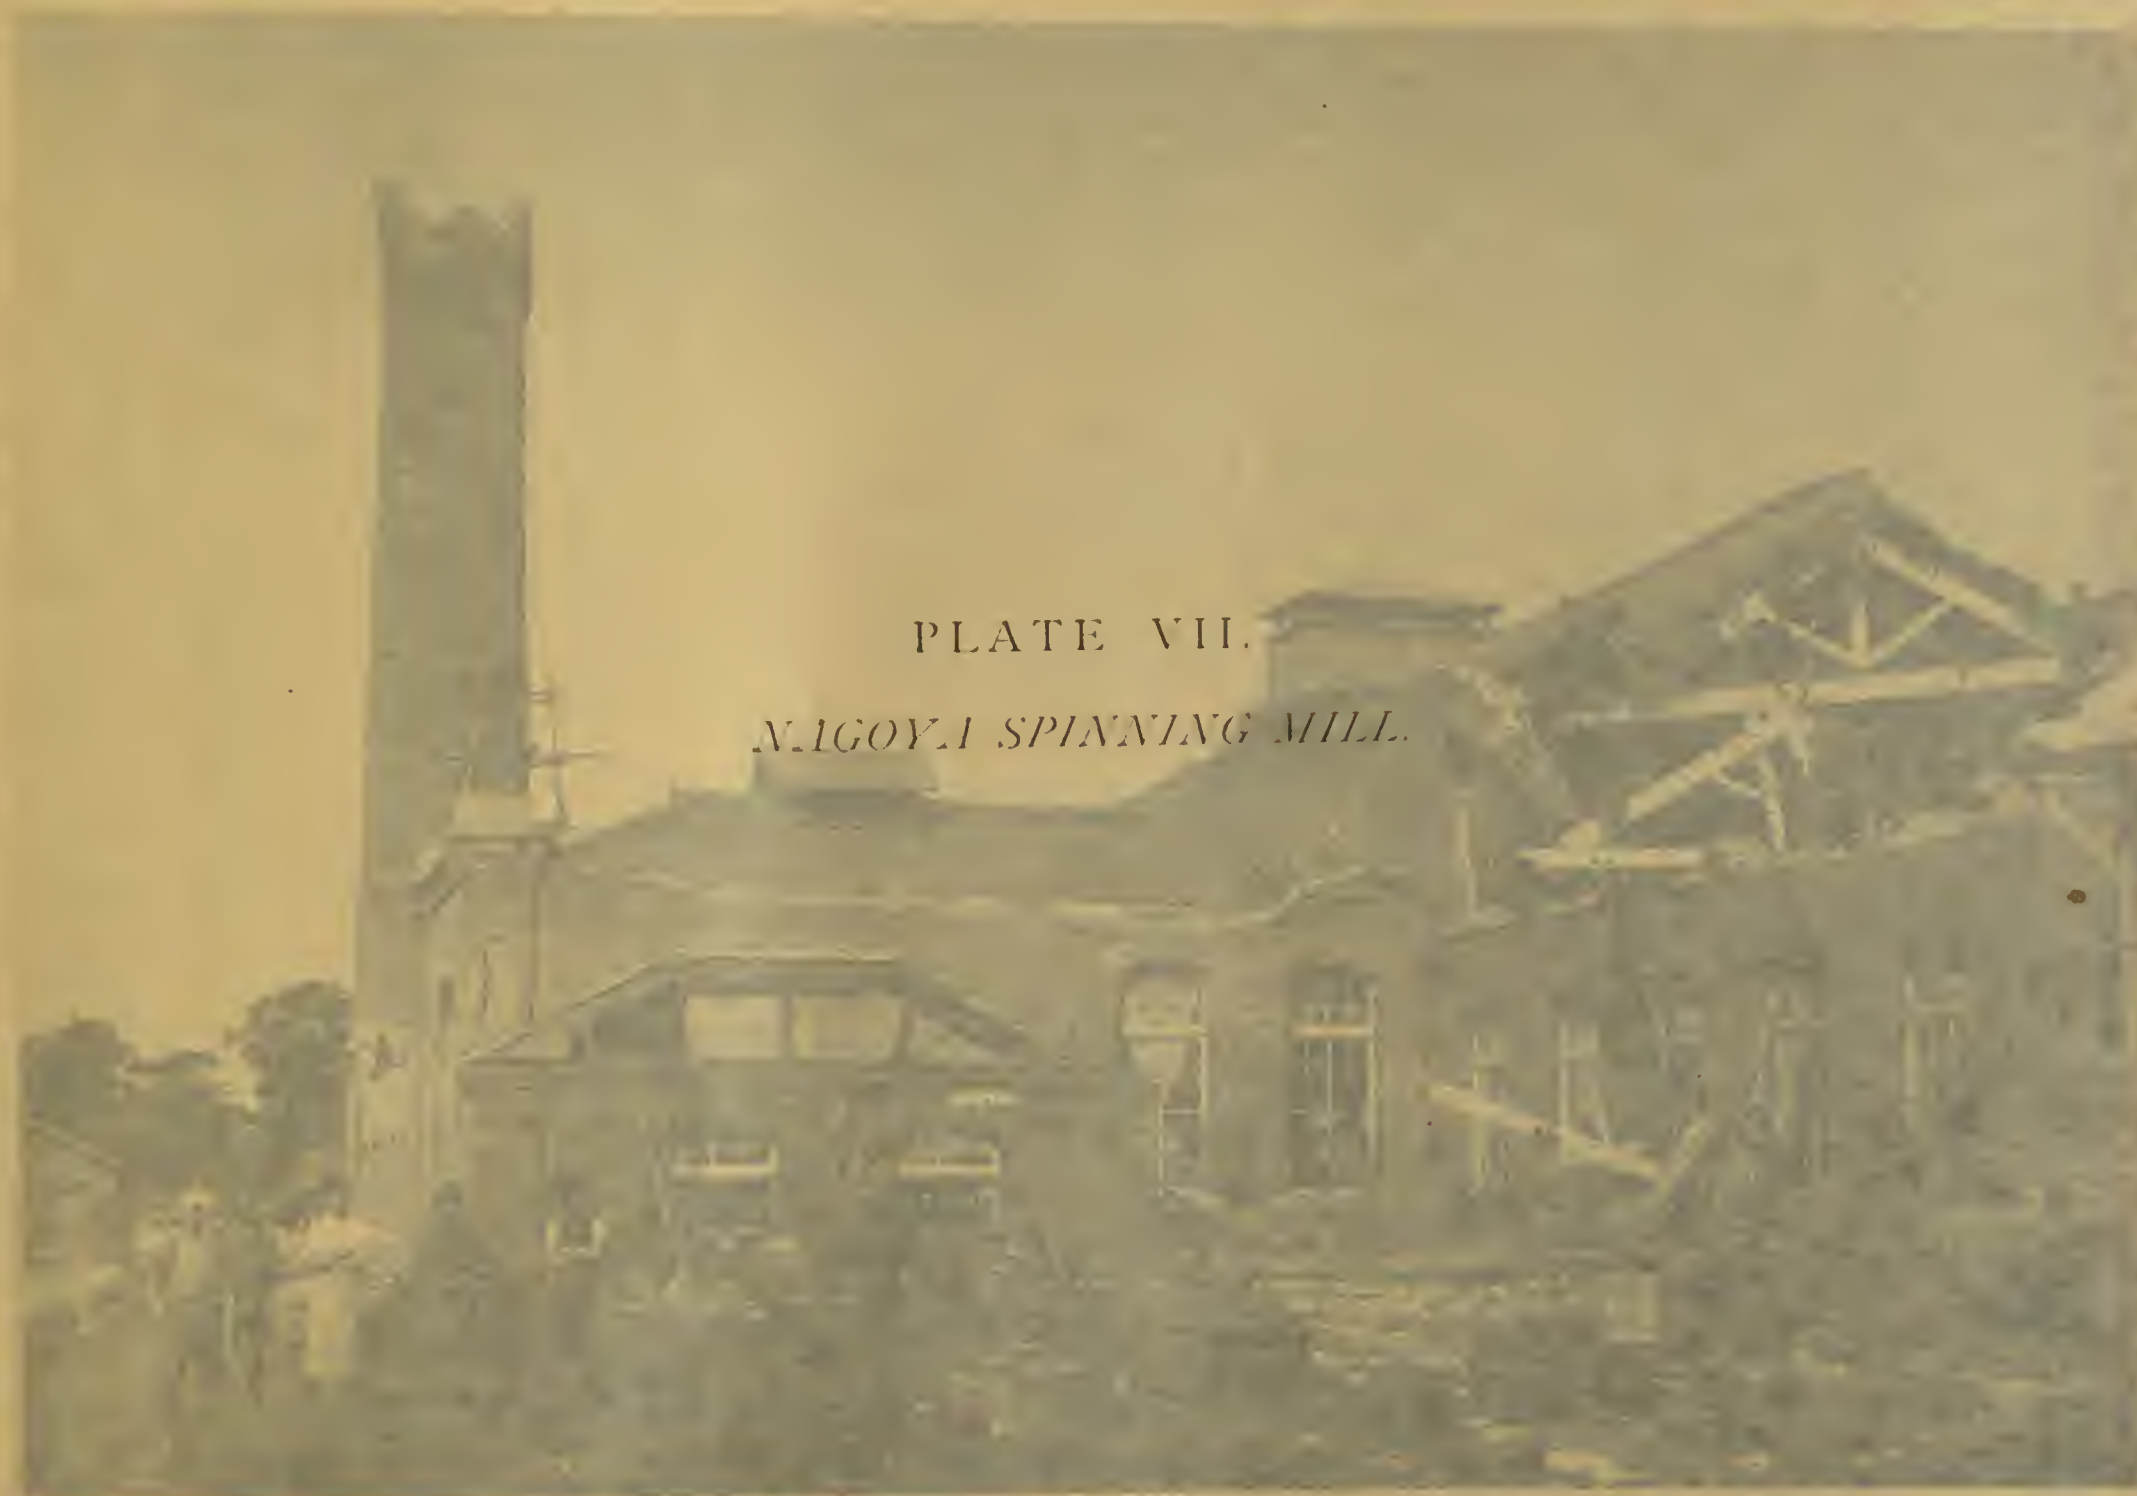
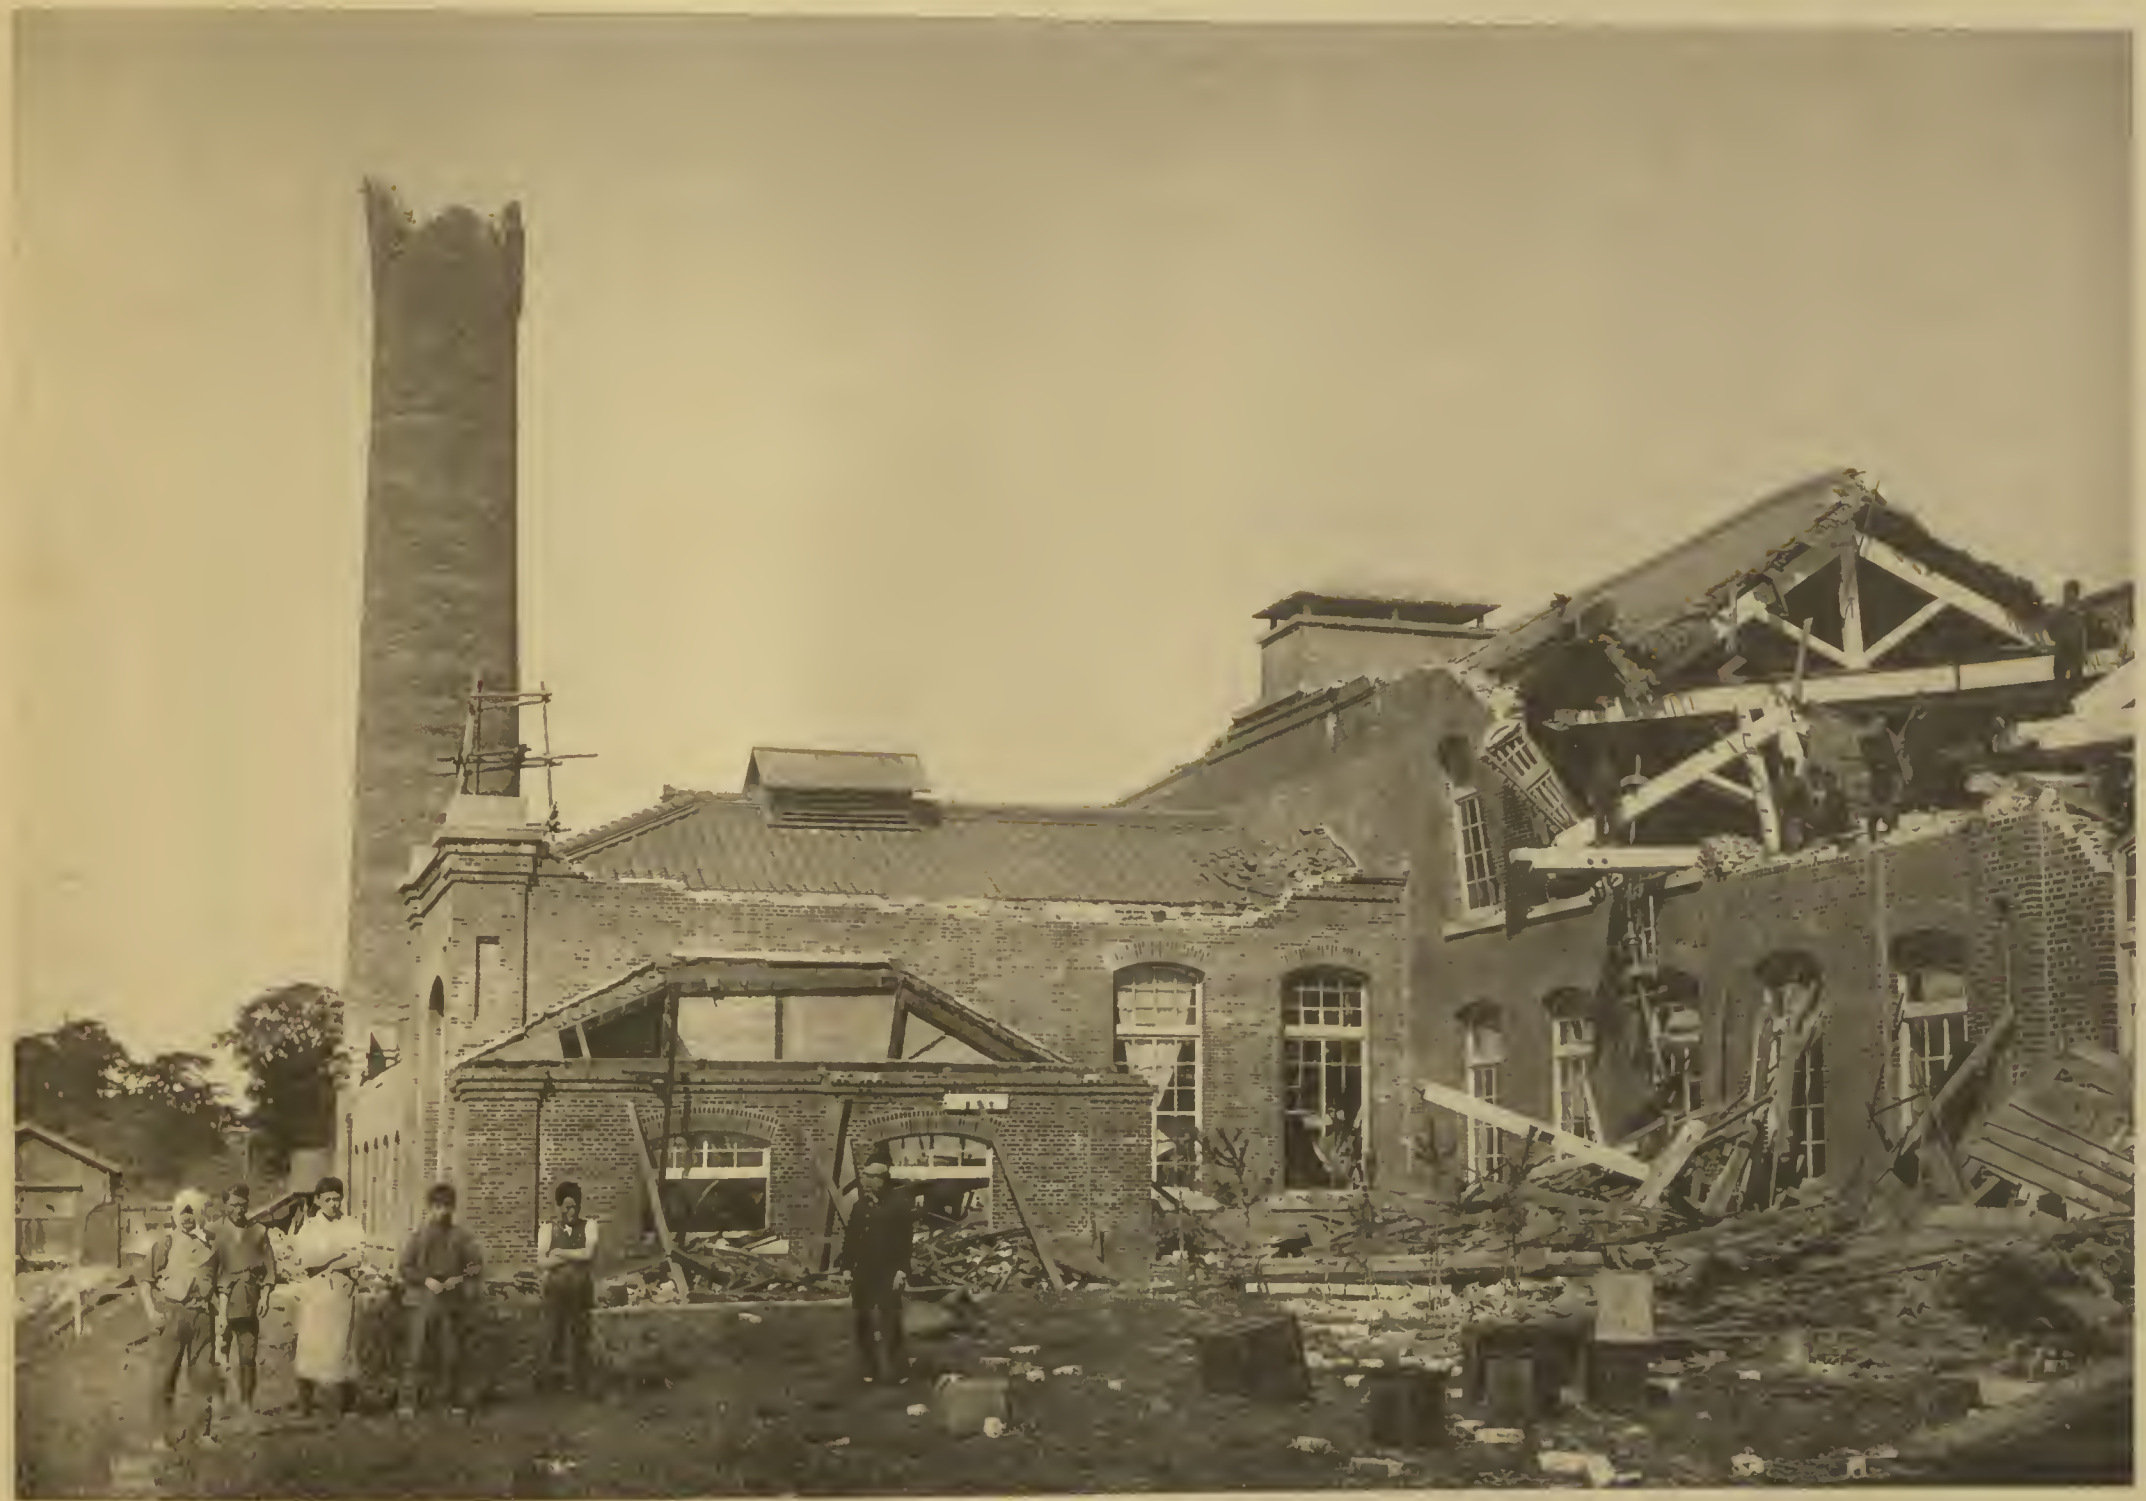
PLATE VII.
NIGOYI SPINNING MILL.

It is notable that the Earthquake was not particularly severe at the Spinning Mill, Japanese houses near it not having been much damaged.

The broken chimney, which was evidently snapped in two,—much as we might snap a light fishing-rod by a sudden jerk,—presents an appearance similar to that of the chimneys which were destroyed in Tokyo, Yokohama, and other places.

One observer describes how he saw a chimney sway from side to side, then crack, apparently separate, and then, after one or two swings more, it toppled over.

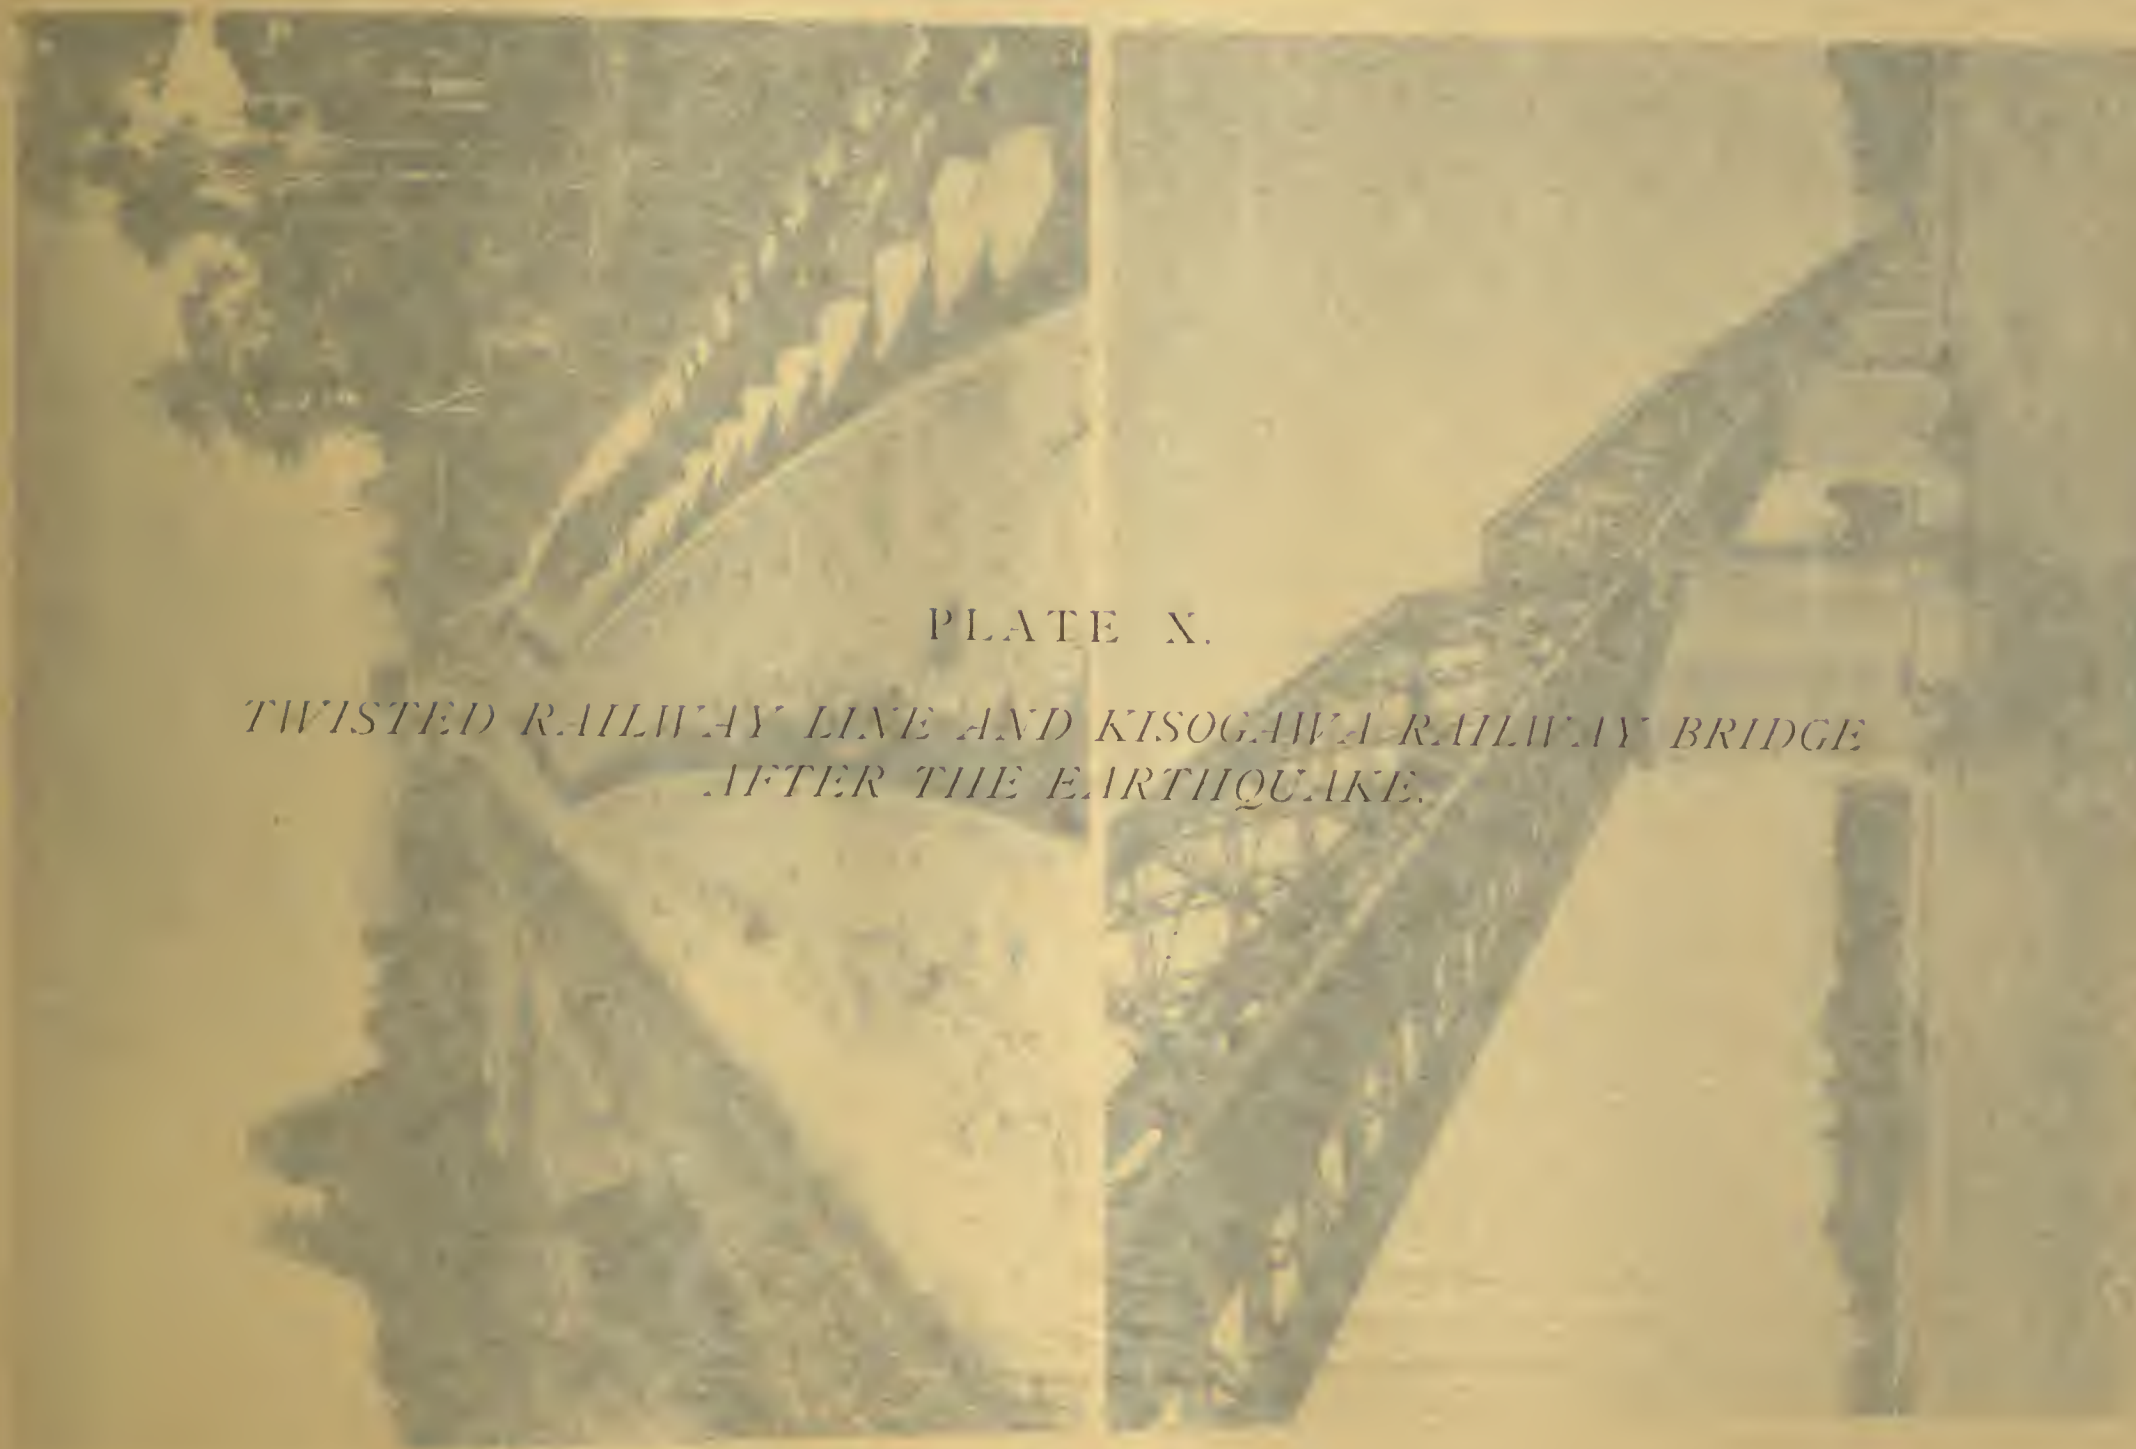
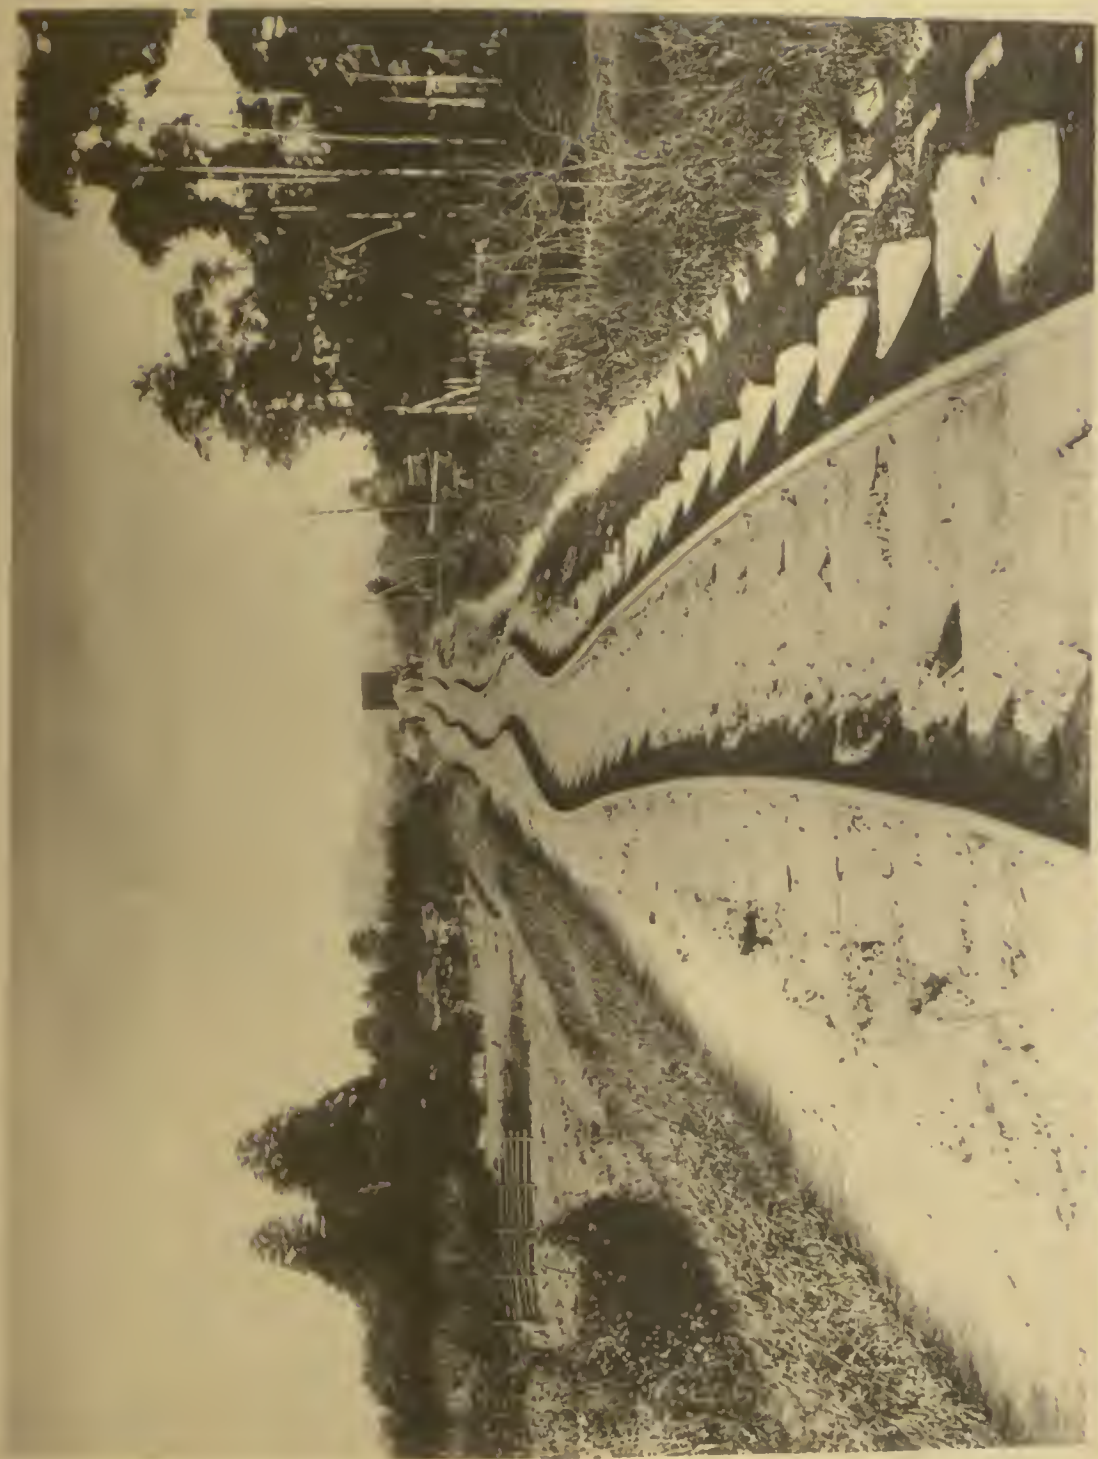
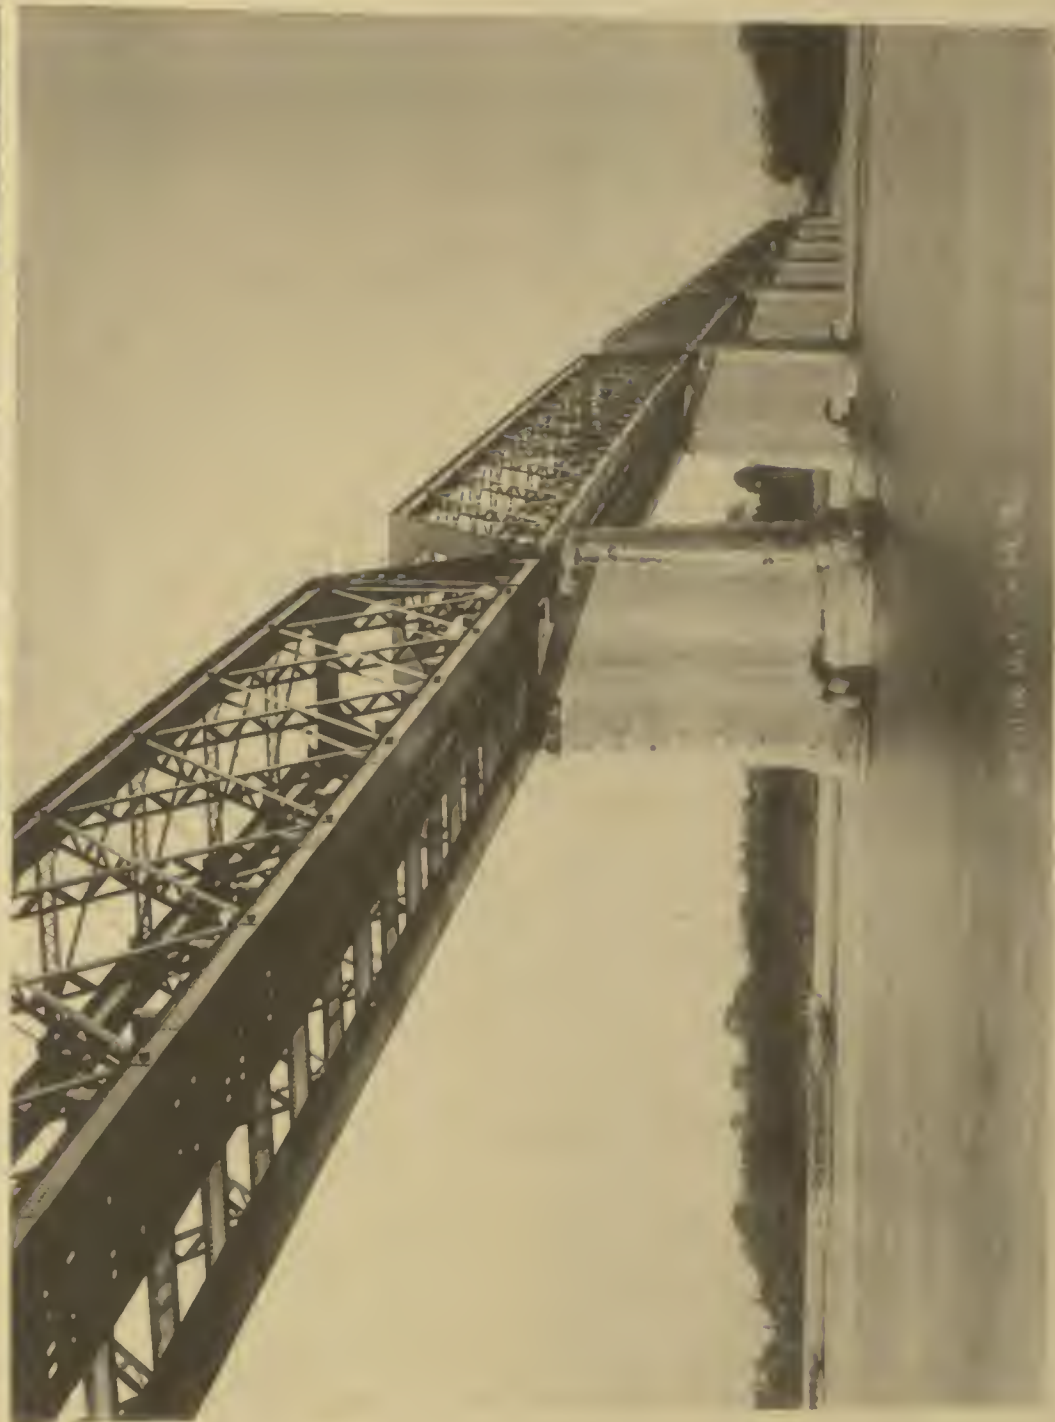
PLATE X.

*TWISTED RAILWAY LINE AND KISOGAWA RAILWAY BRIDGE
AFTER THE EARTHQUAKE.*

A more important feature is however the serpent-like bending of the line. Not only have the metals been deflected but the embankment has suffered a parallel deformation. It seems as if the country here,—and similar appearances are presented at other places,—had been subjected to a permanent longitudinal compression. At each of these bends, although not shewn in the present picture, to the right and left of the line, there is generally a slight depression in the general contour of the country, which possibly may mark the line of an ancient watercourse, in which we may imagine, that the materials are softer than elsewhere. The track crossing such depressions would be crossing lines of weakness, where yielding would be relatively easy, or along which a greater quantity of motion may have passed.

The Kisogawa Bridge which is shewn in the lower picture is 1800 feet in length, and ranks among the finest on this section of the Railway. The girders which are 200 feet in length are supported on brick piers
